ACCEPTABLE GLASS WINDOW/WINDSHIELD REPAIR PROCESSES AND APPROVED VENDORS

RICHARD J. OLSON

BATTELLE
505 KING AVENUE
COLUMBUS, OH 43201

MATERIAL AND PROCESS SPECIFICATION REPORT FOR 09/91 - 12/31/95
CONTRACT NUMBER FO9603-90-D-2217-SD02

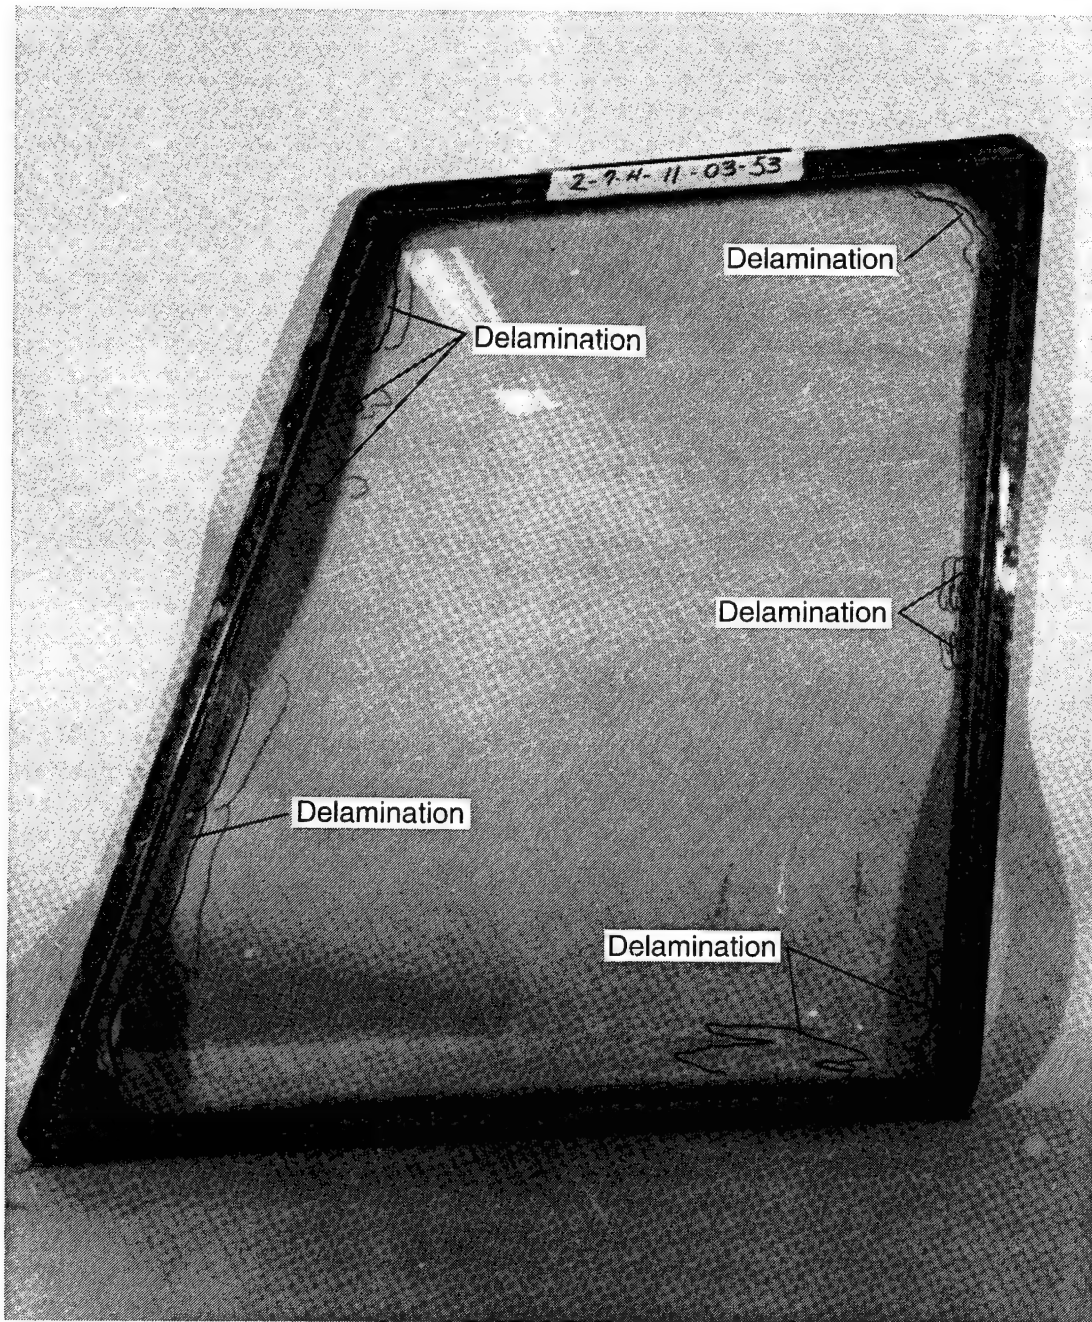
**Figure 4.1 Worst Delamination Observed in All Pressure/Thermal Cycle Tests
(B-52 #1 W/WS, S/N 7-H-11-03-53)**

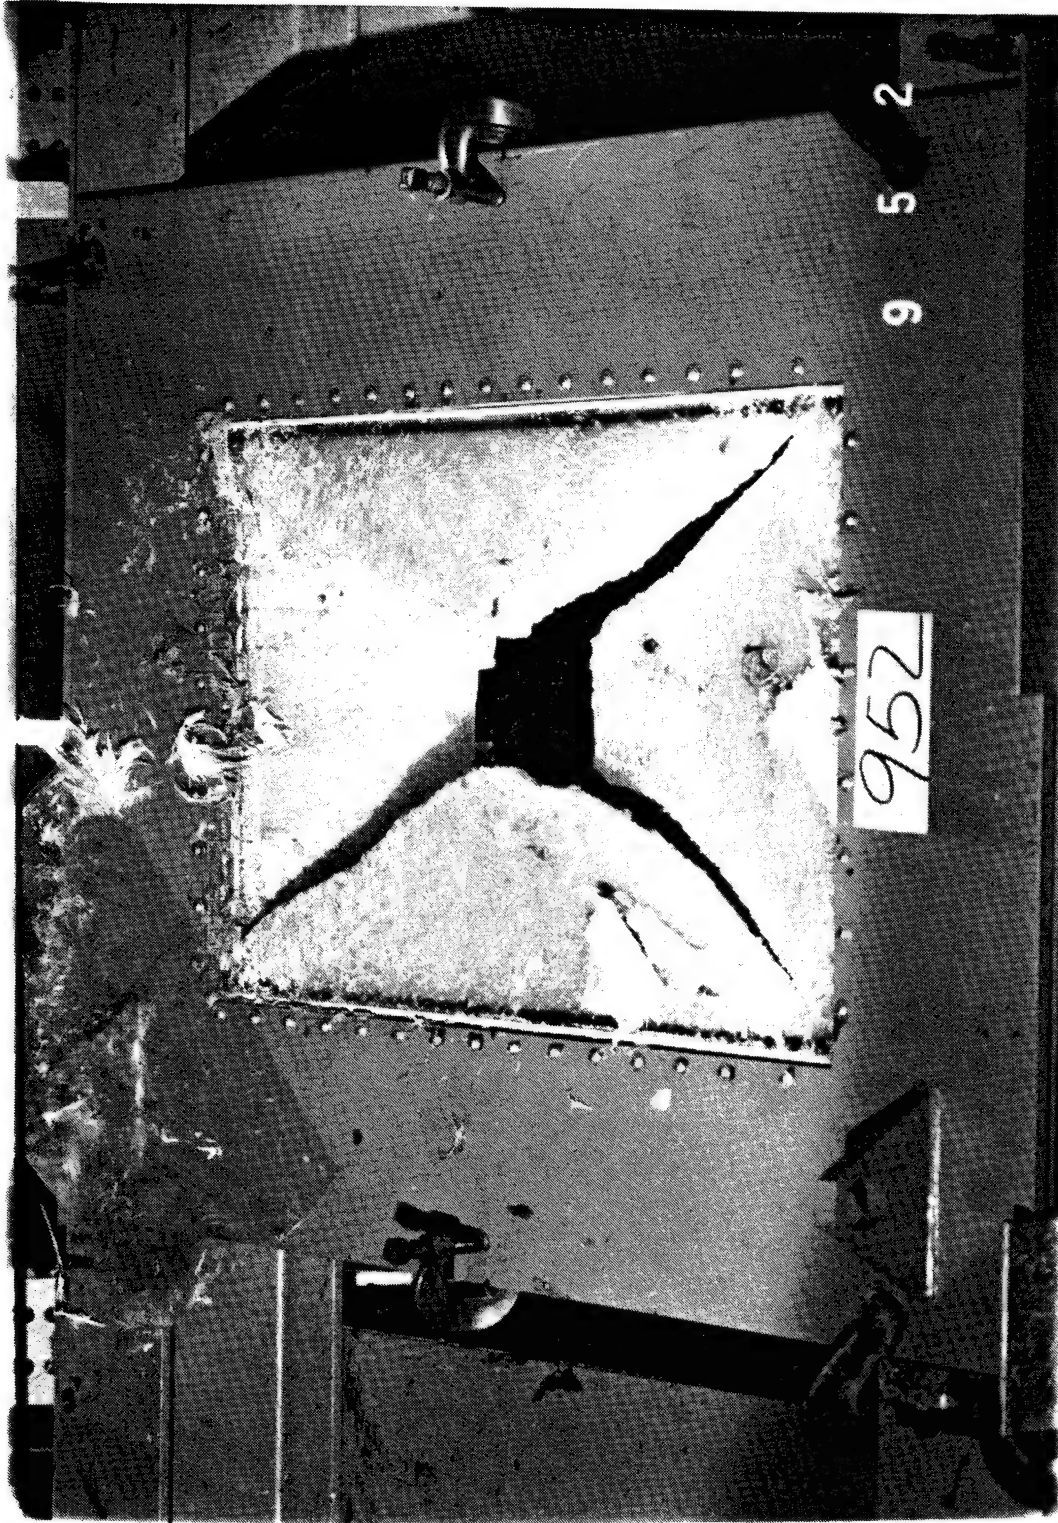
Figure 4.2 Catastrophic W/WS Failure From a 4-Pound Bird Impact at 250 Knots
(B-52 #1 W/WS, S/N 86-H-04-28-693)

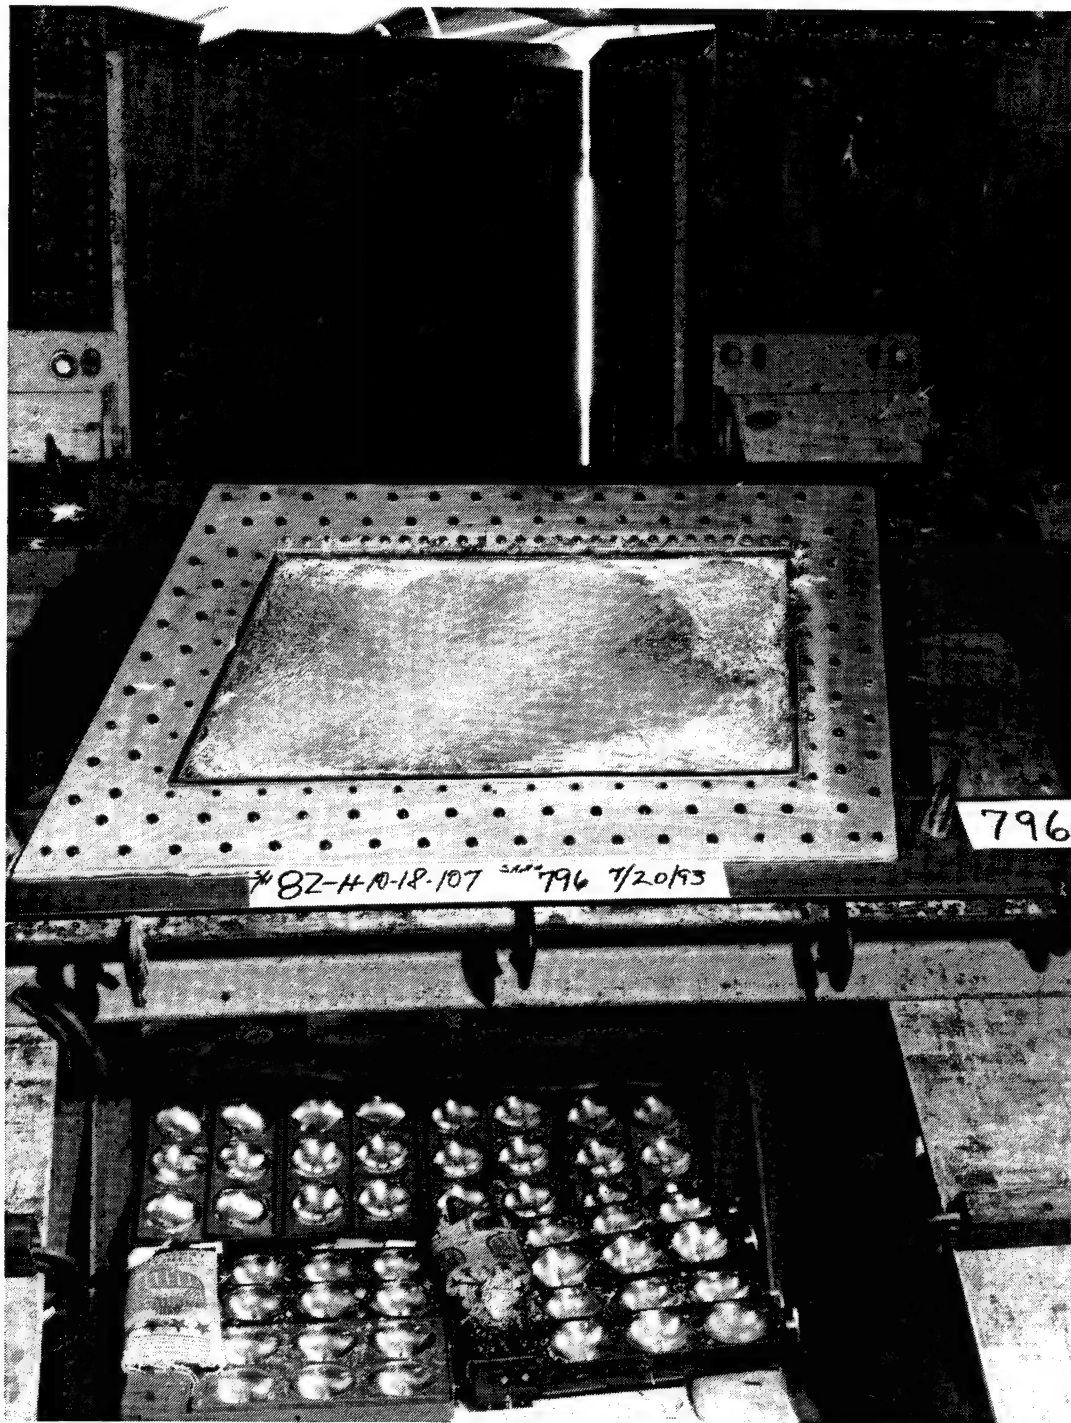
**Figure 4.3 Both Glass Plies Failure From a 4-Pound Bird Impact at 250 Knots
(C/KC-135 W/WS, S/N 83-H-11-21-325)**

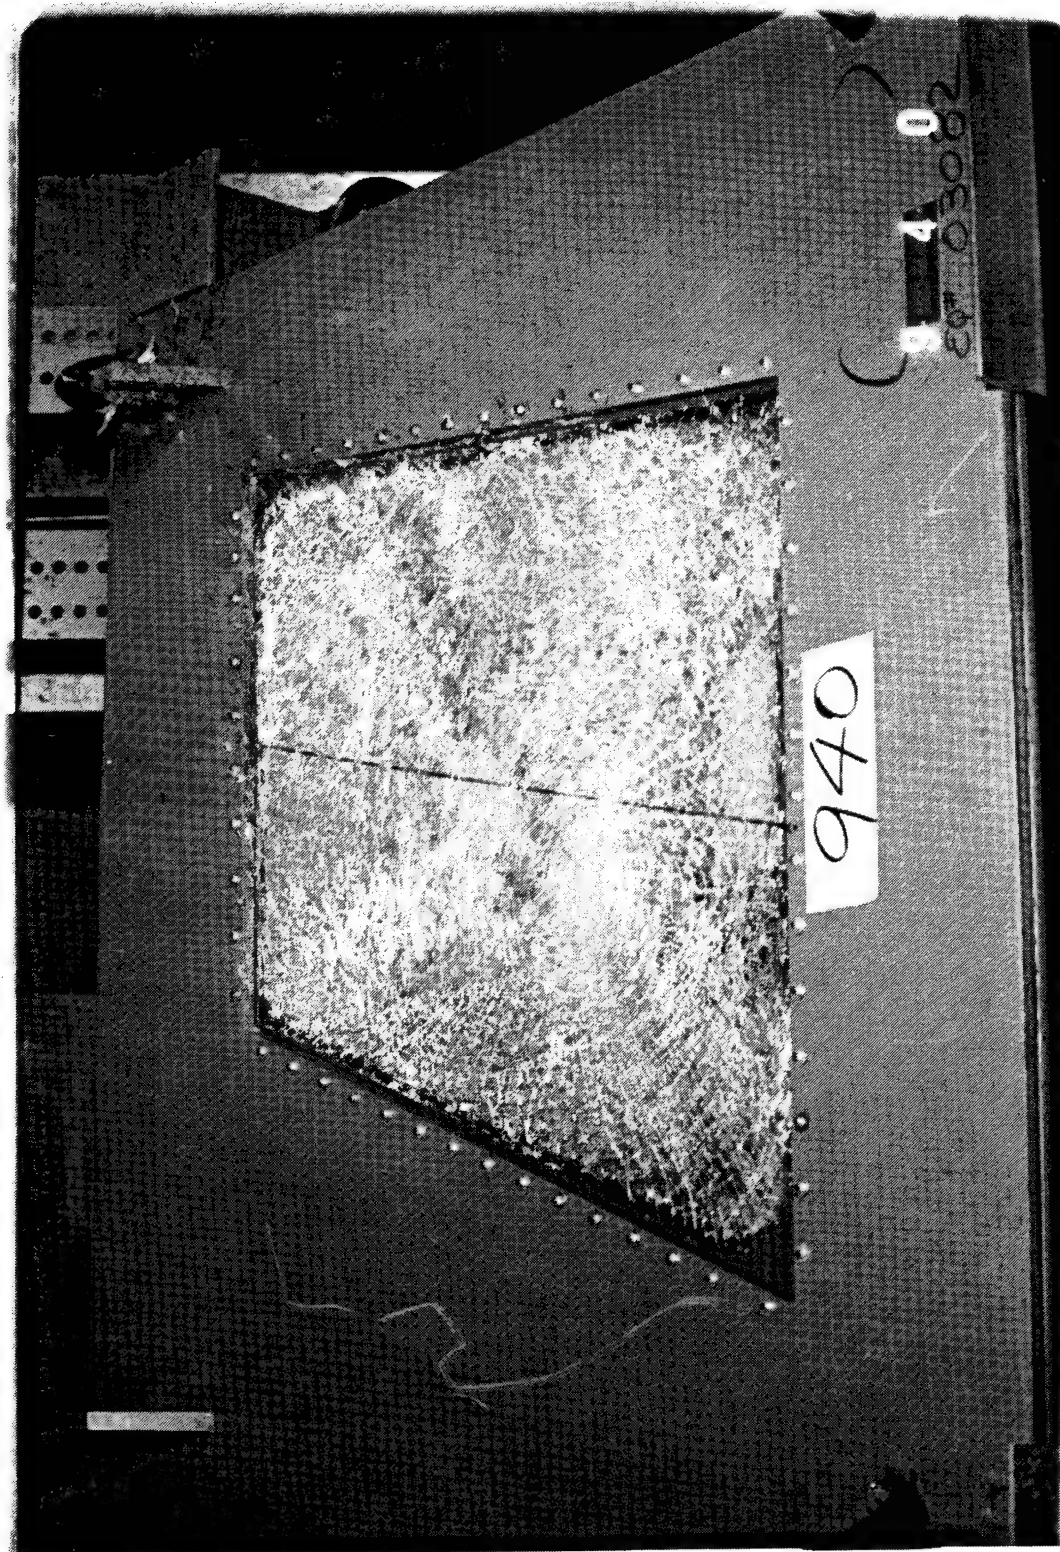
Figure 4.4 Broken Outboard Glass Ply Failure From a 4-Pound Bird Impact at 300 Knots
(B-52 #2 W/WS, S/N 5-H-3-21-17)
